Manhole Inspection Summary

Manhole # S19GG_017MH

Insp Date: **6/13/07 12:39 PM**

Location Address: **2000 PRESSTMAN ST**

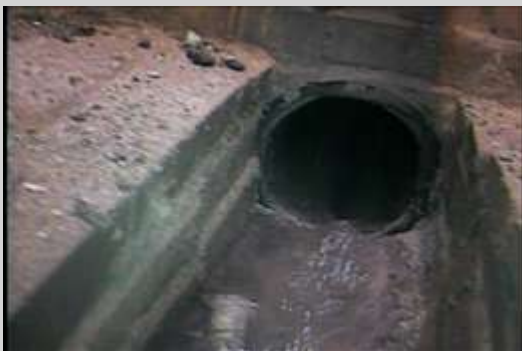
6 O'Clock Inflow

8 in. Circular Gravity Sewer
Pipe In @ 6 O'Clock

Pipe Height: **8.4** (in.) Rod and Bar (Angled)
Pipe Material: **Clay** ☐ Pipe Lined
Invert Depth: **7.00** (ft.) Flow Characteristics: **Slow**
Deposits: ☒ **None** ☐ Mud ☐ Sludge ☐ **Debris** ☐ Grease
Silt Depth: (in.) Deposits Extent:
Infiltration: **None** Pipe Seal Cond: **Sound**
